**Effect of a novel framework design in ceria-stabilized
zirconia/alumina nanocomposite (Ce-TZP/A)-based
all-ceramic crowns**

**Inaugural-Dissertation
zur Erlangung des Doktorgrades
der Zahnheilkunde**

**der Medizinischen Fakultät
der Eberhard Karls Universität
zu Tübingen**

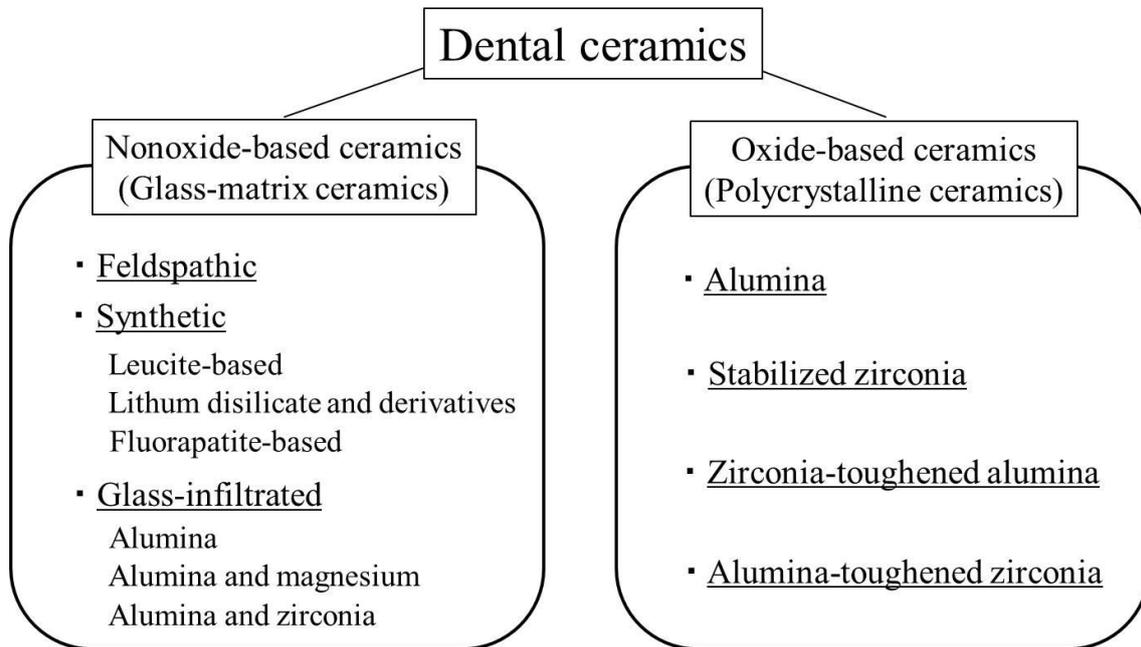
Figure 1. Classification of all-ceramic materials (Larsson and Wennerberg 2014; Gracis et al. 2015).

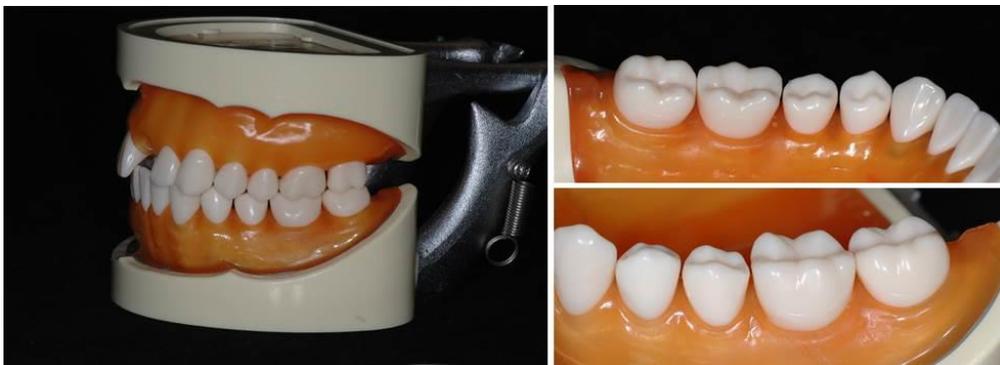
Figure 4. Melamine formaldehyde resin tooth model.

An artificial left mandibular first molar tooth (Simple Root Tooth Model A50-A-500, Nissin Dental Products Inc., Kyoto, Japan) made of melamine formaldehyde resin was used as an abutment tooth model (Figure 4, Figure 5 a, b). Abutment tooth preparation for all-ceramic crown was performed on the artificial tooth in the standard manner, i.e., with a 2.0-mm occlusal reduction of the functional cusp, a 1.5-mm occlusal reduction of the non-functional cusp, a 1.0-mm shoulder finish line with a rounded inner edge, and a convergence angle of approximately 6° (Figure 5 c, d).

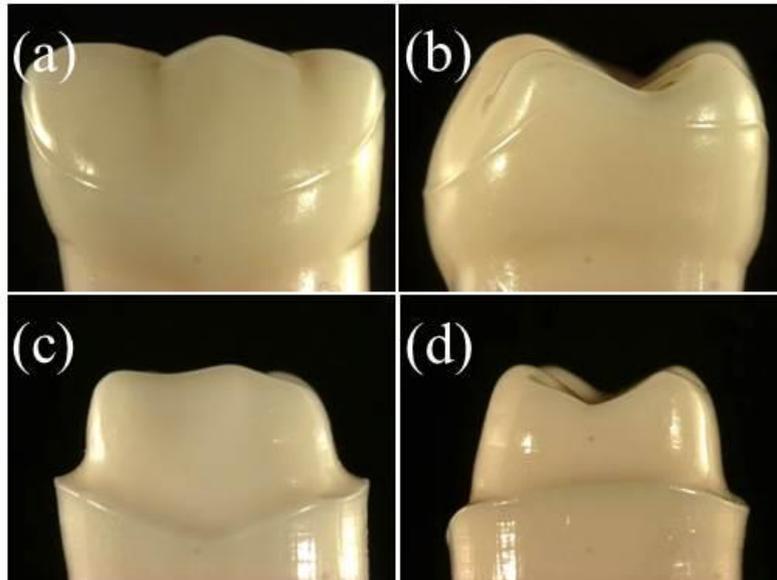
Figure 5. Abutment tooth preparation for all-ceramic crown (a, b, before preparation; c, d, after preparation).

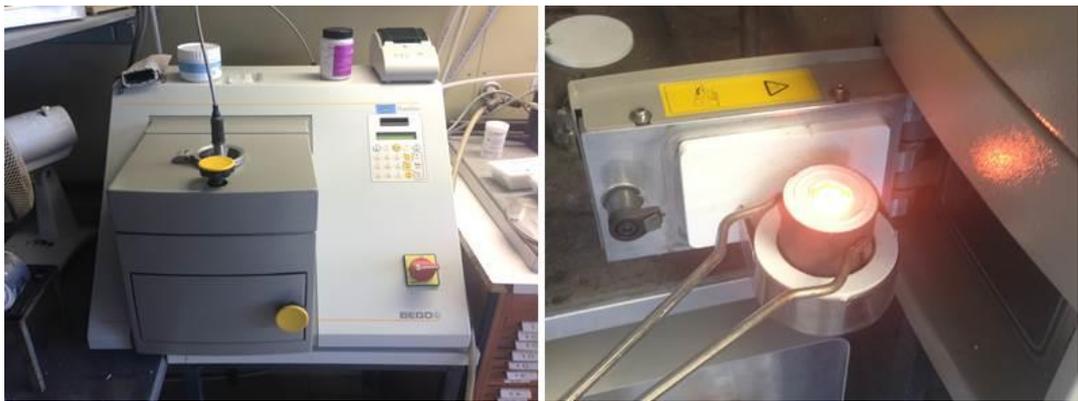
Figure 7. Casting machine.

To scan tooth information for subsequent veneering of porcelain on the zirconia framework, metal tooth analogs were replicated from the prepared artificial abutment tooth by taking an impression with hydrophilic vinyl polysiloxane impression material (Omnidouble, Omnident Dental-Handelsgesellschaft GmbH, Rodgau Nieder-Roden, Germany). A milling wax (Thowax gray opaque, Yeti Dental GmbH, Engen, Germany) was flowed into the impression, and a wax-up was made (Figure 6). The wax-up was invested with carbon-free phosphate-bonded investment material (GC Fujivest Premium, GC Eupore N.V., Leuven, Belgium), and cast using cobalt-chrome (Co-Cr) alloy (StarLoy C, DeguDent GmbH, Hanau, Germany) with a casting machine (Nautilus CC-plus, BEGO GmbH, Bremen, Germany) (Figure 7). After casting, Co-Cr tooth analogs were adjusted and polished (Figure 8).

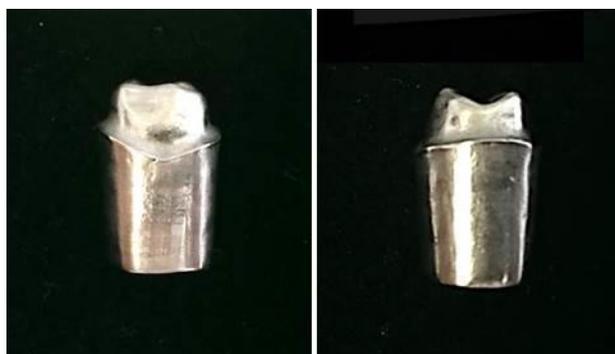
Figure 8. Co-Cr tooth analog.

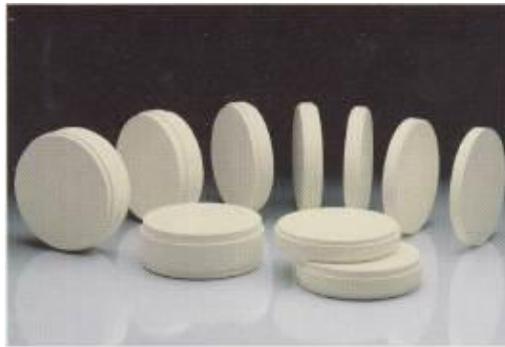
Figure 9. Ce-TZP/A blanks.

Zirconia frameworks were made of Ce-TZP/A blanks (C-Pro Nano-Zirconia, Panasonic Healthcare Co., Ltd., Tokyo, Japan) (Figure 9) using a CAD/CAM system (C-Pro System, Panasonic Healthcare Co., Ltd.).

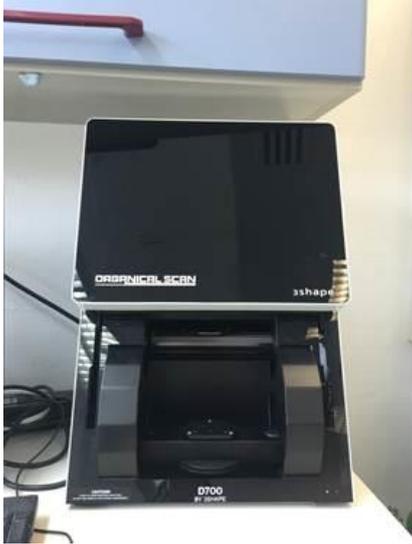
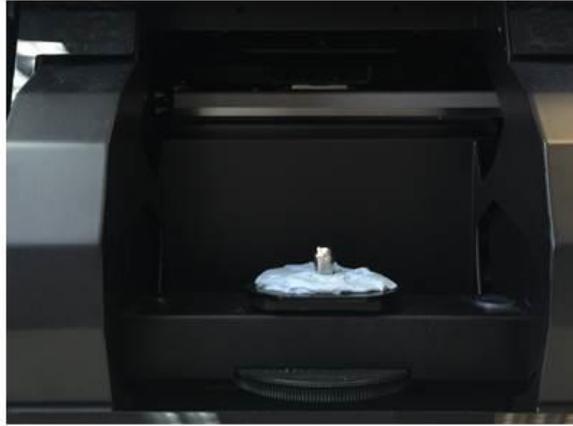
Figure 10. Digital scanner.

The Co-Cr tooth analog was coated with antireflection spray (CEREC Optispray, Sirona Dental GmbH, Salzburg, Austria) and scanned with a digital scanner (D700-3SP Scanner, Panasonic Healthcare Co., Ltd.) to obtain information for the prepared abutment tooth (Figure 10). After scanning, a zirconia framework was designed by a software (3Shape Dental Designer, 3Shape A/S, Copenhagen, Denmark) and milled using a Ce-TZP/A blank (Figure 11).

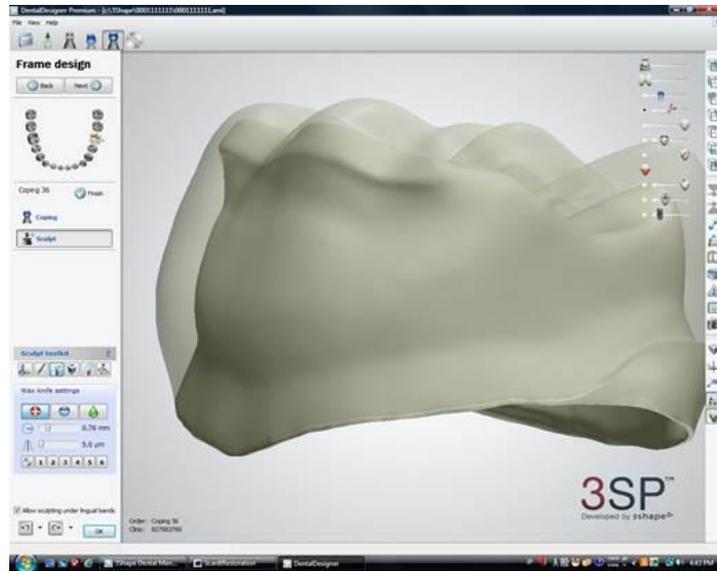
Figure 11. Framework design by a CAD software.

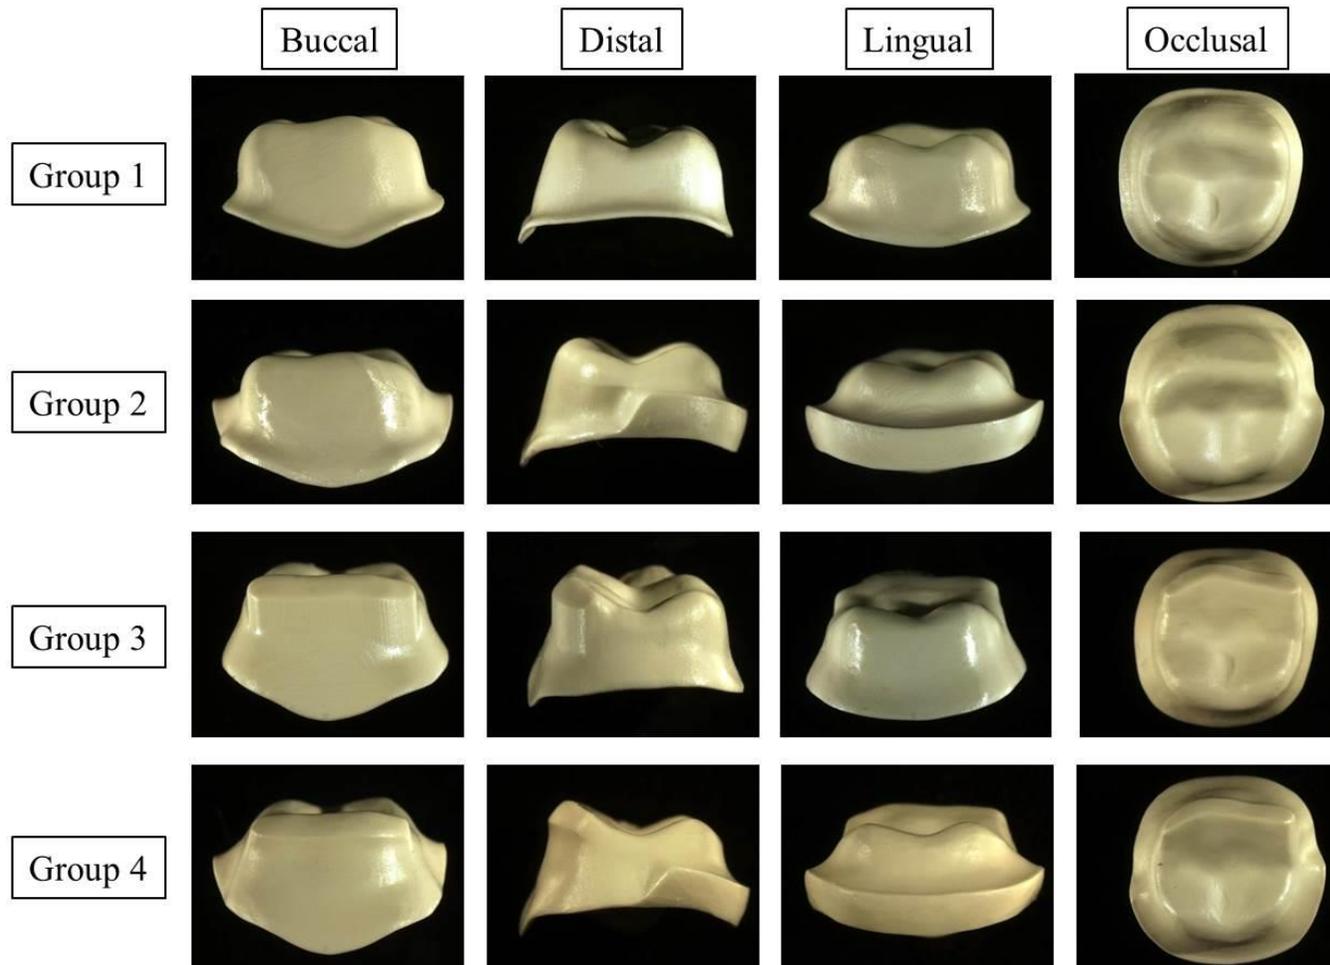
Figure 12. Ce-TZP/A frameworks. Group 1, occlusal anatomical shape; Group 2, with an additional lingual supporting structure; Group 3, with an additional buccal supporting structure; Group 4, with additional buccal and lingual supporting structures.

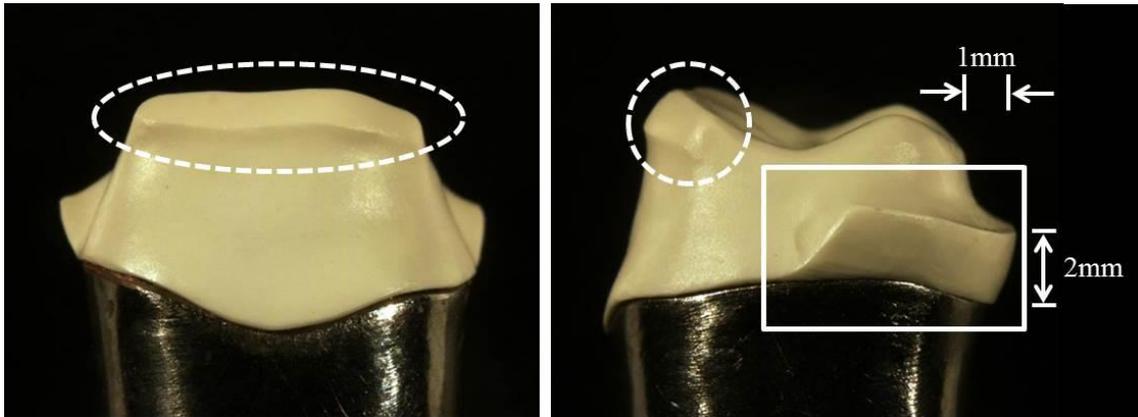
Figure 13. Supporting structures. Dotted areas and solid area indicate buccal and lingual supporting structures, respectively.

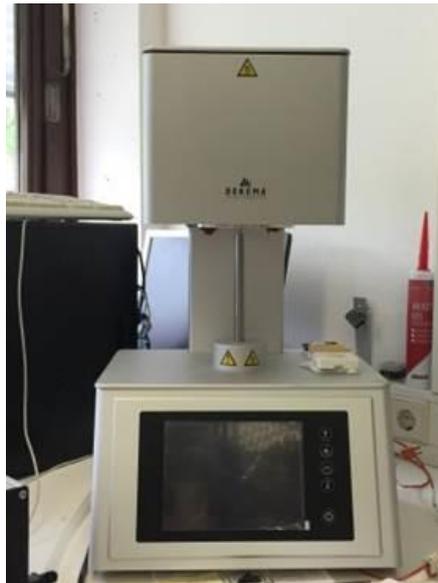
Figure 14. Dental porcelain furnace.

The layering procedure comprised the following: wash-bake (VITA VM9 Effect Liner EL, VITA Zahnfabrik H. Rauter GmbH & Co. KG, Bad Säckingen, Germany); first and second dentin (VITA VM9 Base Dentin A3, VITA Zahnfabrik H. Rauter GmbH & Co. KG); and glazing (VITA Akzent, VITA Zahnfabrik H. Rauter GmbH & Co. KG), which was performed in a dental furnace (Austromat 624, Dekema Dental-Keramiköfen GmbH, Freilassing, Germany) according to the manufacturer's instructions (Figure 14, Table 6).

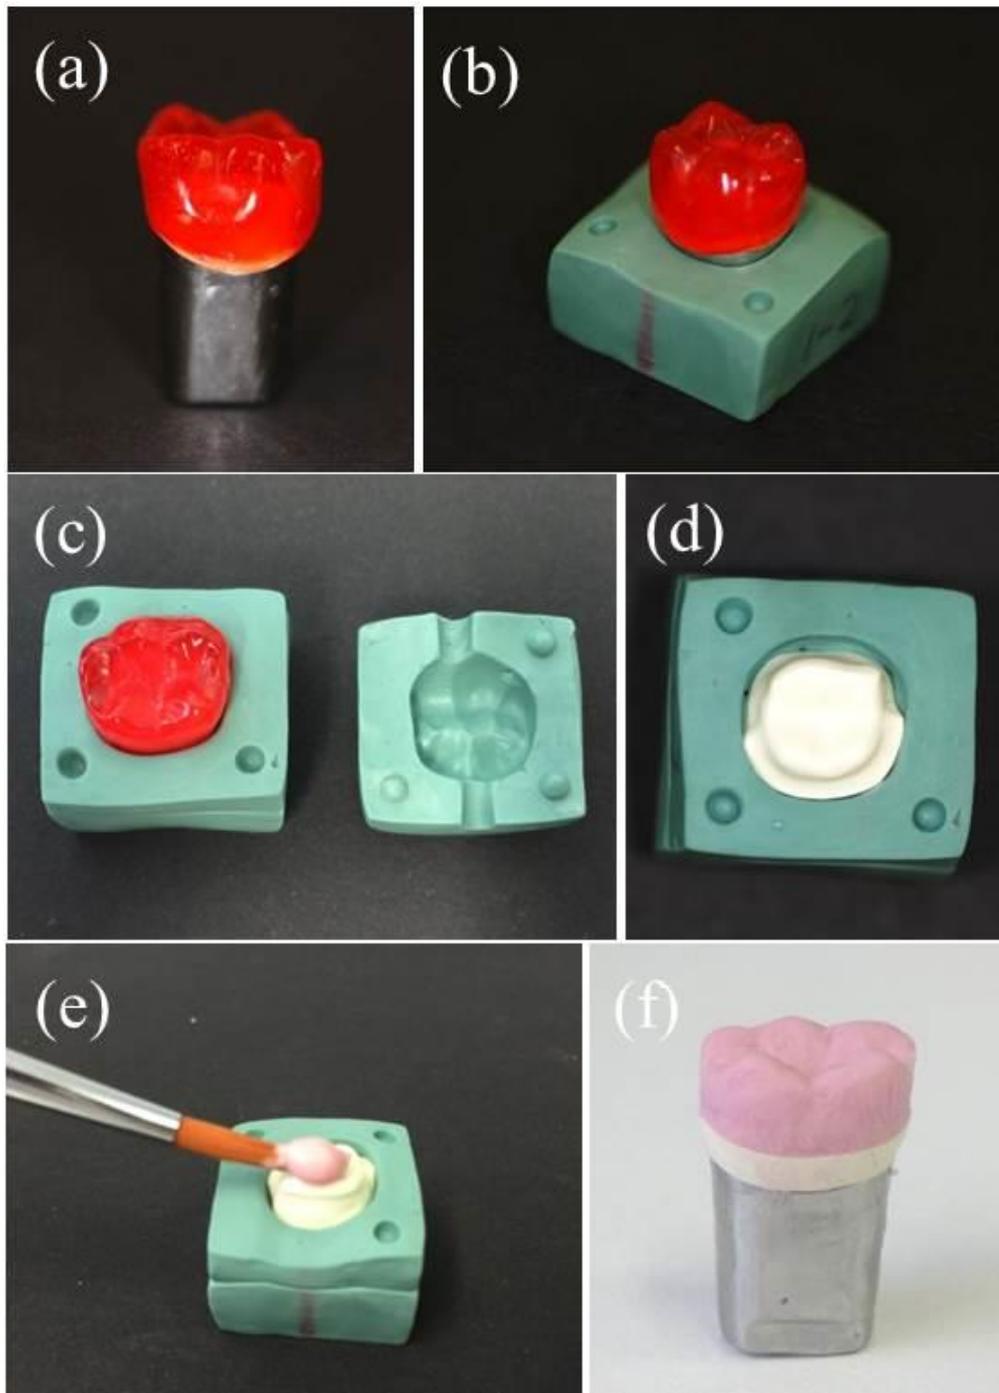
Figure 16. Process of veneering porcelain. (a, fabrication of a resin-up replica crown for each framework; b, c, fabrication of mold ; d, fixation of framework; e, layering porcelain on the framework; (f) build-up of porcelain.

Before wash-bake firing (Figure 15), molds for reproduction of the tooth form before tooth preparation (Figure 5 a, b) were made using impression material (FUSION II Putty Type, GC Co., Ltd., Tokyo, Japan) for layering porcelain on the Ce-TZP/A framework. In brief, a resin-up replica crown for each framework was made using a self-curing modelling acrylic (Palavit G, Heraeus Kulzer GmbH, Hanau, Germany) (Figure 16 a). This replica crown was fixed on the Co-Cr tooth analog, and an impression was taken (Figure 16 b, c). For the dentin layer, base dentin powder was mixed with the liquid and filled into the mold, which had been precoated with isolating liquid (Carat, Hager & Werken GmbH, Düisburg, Germany) (Figure 16 d, e). A tissue was used to remove excess moisture from the porcelain build-up on the Ce-TZP/A framework, and the framework was fired (Figure 16 f). Finally, a glazing firing was performed to fabricate all-ceramic crowns using a Ce-TZP/A framework (Figure 17).

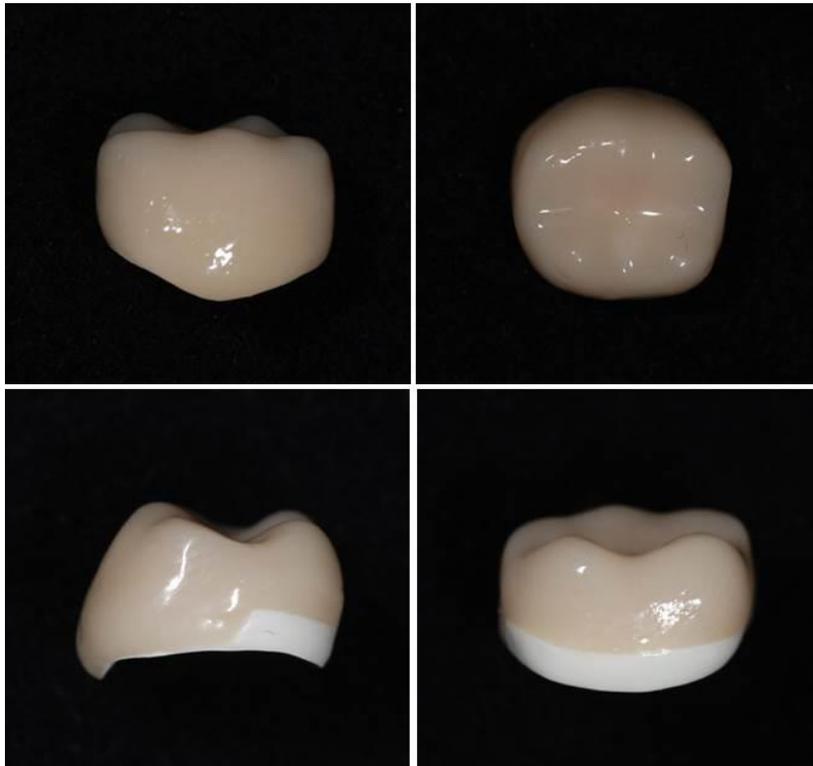
Figure 17. Ce-TZP/A-based all-ceramic crown after glazing firing.

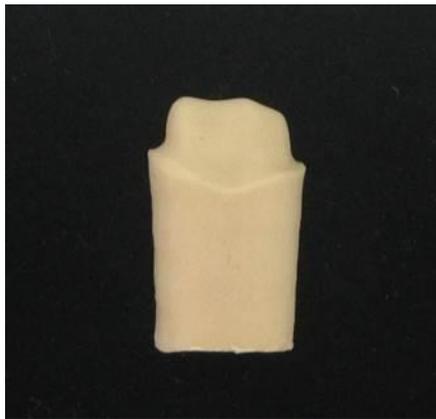
Figure 18. Resin tooth analog.

Resin tooth analogs were made from a fast-curing resin that was based on modified polyester (Technovit 4000, Heraeus Kulzer) (Figure 18). In brief, an impression of the prepared abutment tooth (Figure 5 c, d) was taken with hydrophilic vinyl polysiloxane impression material (Omnidouble, Omnident Dental-Handelsgesellschaft GmbH). Resin powder was mixed with liquid according to the manufacturer's instructions, then flowed into the impression and polymerized. After polymerization, resin tooth analogs were stored in distilled water for 24 h at 37° C.

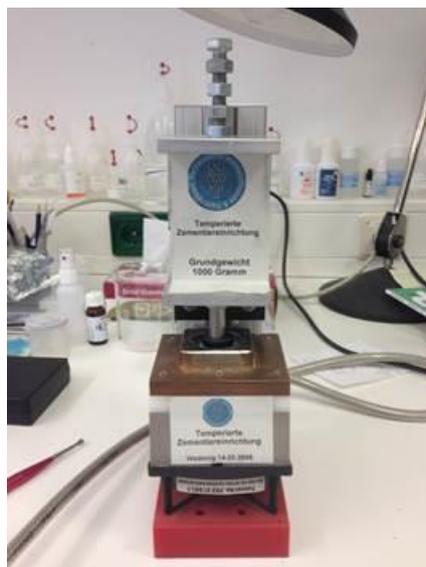
Figure 19. Original loading device for cementation of Ce-TZP/A-based crowns.

After pretreatment, all crowns were cemented to resin tooth analogs using self-adhesive resin cement (RelyX Unicem 2, 3M ESPE GmbH, Neuss, Germany). In this study, this dual-cure cement was cured by chemical polymerization. During this procedure, all specimens were held with 1 kg of weight applied to the top of the crown with a 4-mm stainless steel ball for 6 min using an original loading device (Figure 19). Excess cement was removed after 2.5 min during cementation. All cemented specimens were stored in distilled water for 24 h at 37° C.

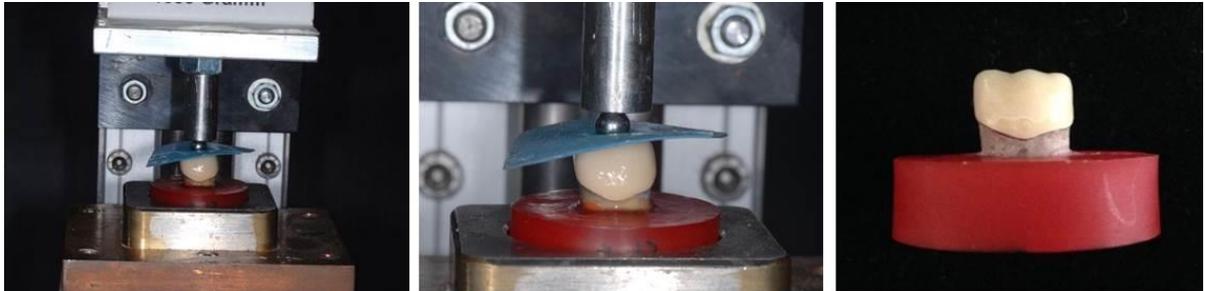
Figure 20. Fixation of a specimen to an acrylic disk block.

Each specimen was embedded in an acrylic block, positioned using an original loading device such that the long axis of the tooth was 2.0 mm below the margin line (Figure 20). Fixed specimens were stored in distilled water for 24 h at 37° C.

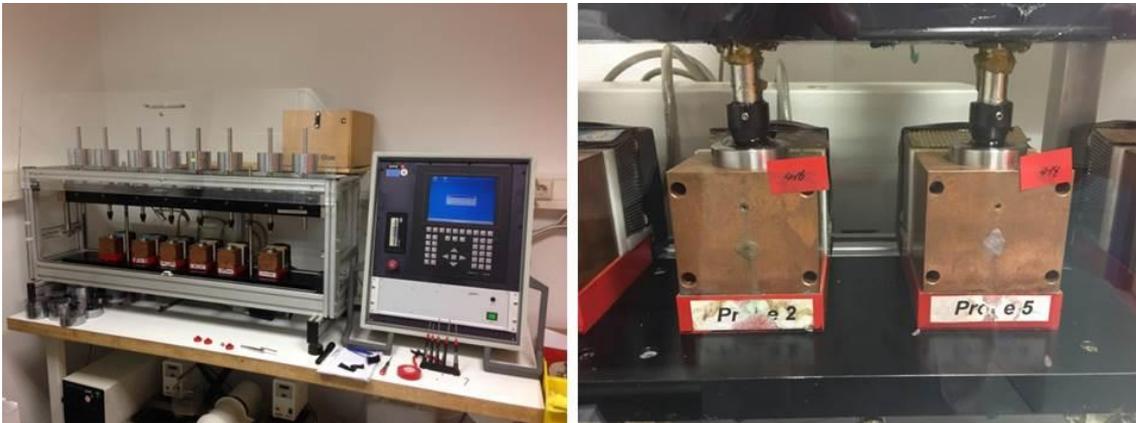
Figure 21. Masticator.

Prior to fracture loading test, half of the specimens in each experimental group ($n = 12$) underwent mechanical preloading. Specimens were mounted into a metal holder, and mechanical preloading was conducted using a masticator (Willytec, SD Mechatronik GmbH, Feldkirchen-Westerham, Germany). The loading simulation, which was supposed

to represent 5 years of oral service, used the following parameters (Rosentritt et al, 2009): weight, 49 N; cycles, 1.2 million; frequency, 1.4 Hz; and speed, 40 mm/s (Figure 21). The antagonist used material comprising 5-mm magnesium silicate balls (Steatite, CeramTec GmbH, Plochingen, Germany). The antagonist was placed at the occlusal surface of each crown, and adjustments were made using red articulating paper and vertical-centric loading to confirm three-point contact (Figure 22).

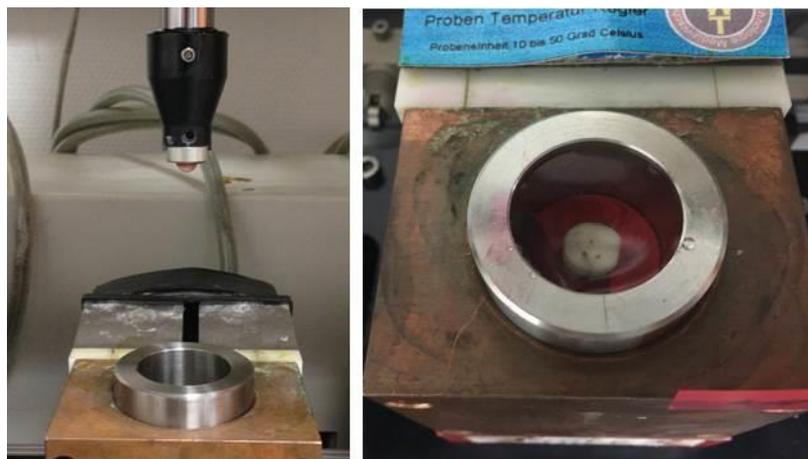
Figure 22. Antagonist (left) and three-point contact with the fixed specimen (right).

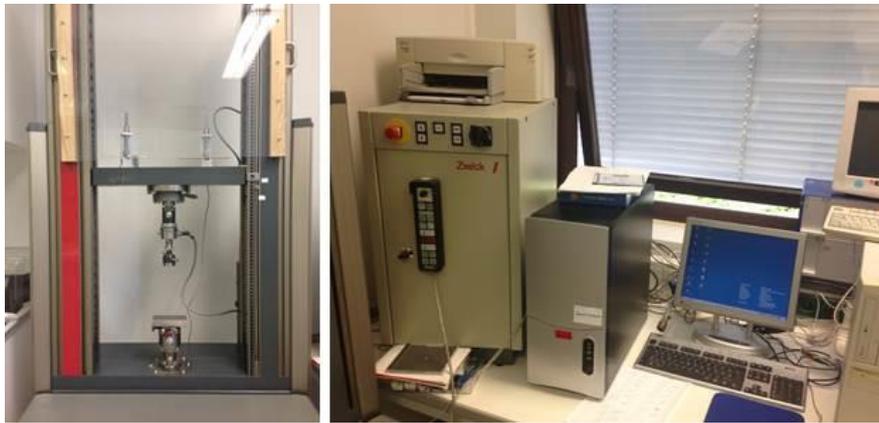
Figure 23. Universal testing machine.

Fracture load of each crown, either without (-) or with (+) chewing simulation, was conducted using a universal testing machine (Z010, Zwick GmbH, Ulm, Germany) (Figure 23). The crown was mounted into the metal holder. Using a 4.0-mm stainless steel ball as a loading rod tip, a vertical load was then applied at the central fossa of each crown at a crosshead speed of 0.5 mm/min until fracture occurred (Figure 24).

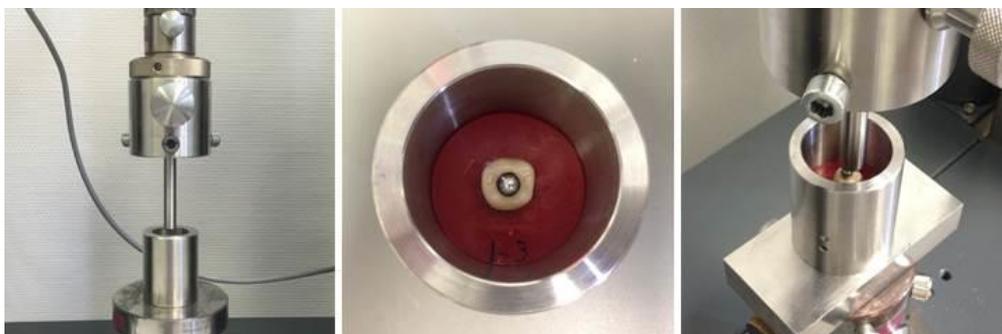
Figure 24. Fracture loading test.

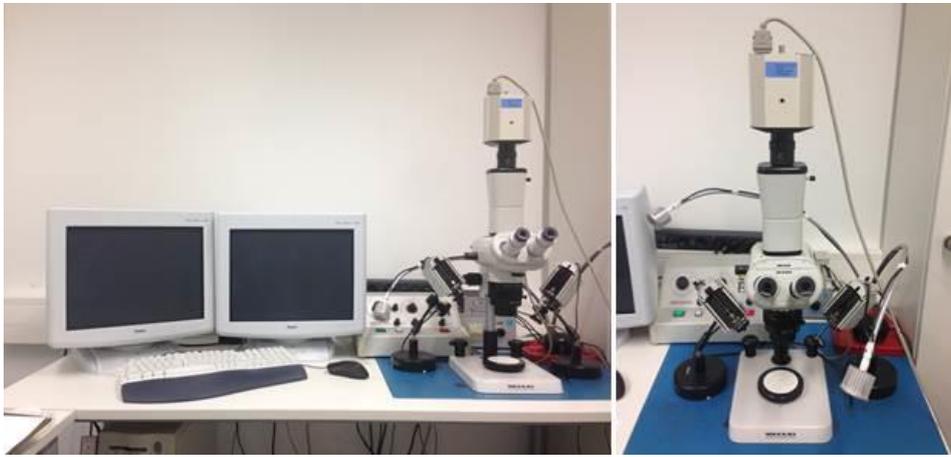
Figure 25. Stereomicroscopy.

After fracture loading test, failure mode of each crown was observed by stereomicroscopy (M400 Photomicroscope, Wild Heerbrugg AG, Heerbrugg, Switzerland) and scanning electron microscopy (SEM; LEO 1430, Carl Zeiss AG, Oberkochen, Germany) (Figure 25, 26).

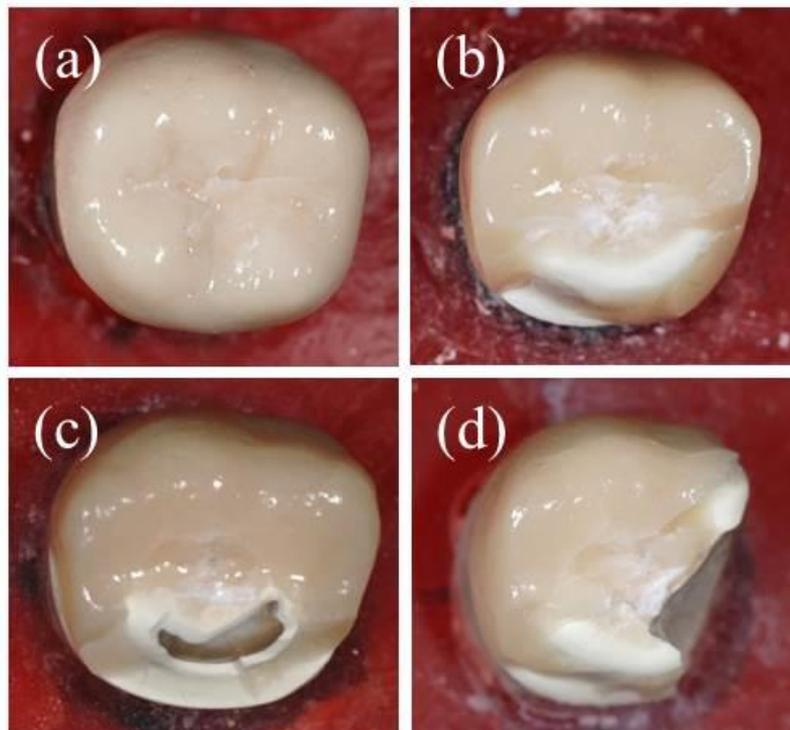
Figure 27. Failure mode classification. Partial fracture: cracking of porcelain veneer (a) and chipping of porcelain veneer (b). Complete fracture: fracture of Ce-TZP/A framework (c) and fracture of tooth analog (d).

Failure mode was classified into two groups: partial fracture (cracking or chipping of porcelain veneer) and complete fracture (fracture of Ce-TZP/A framework or tooth analog) (Table 7, Figure 27).

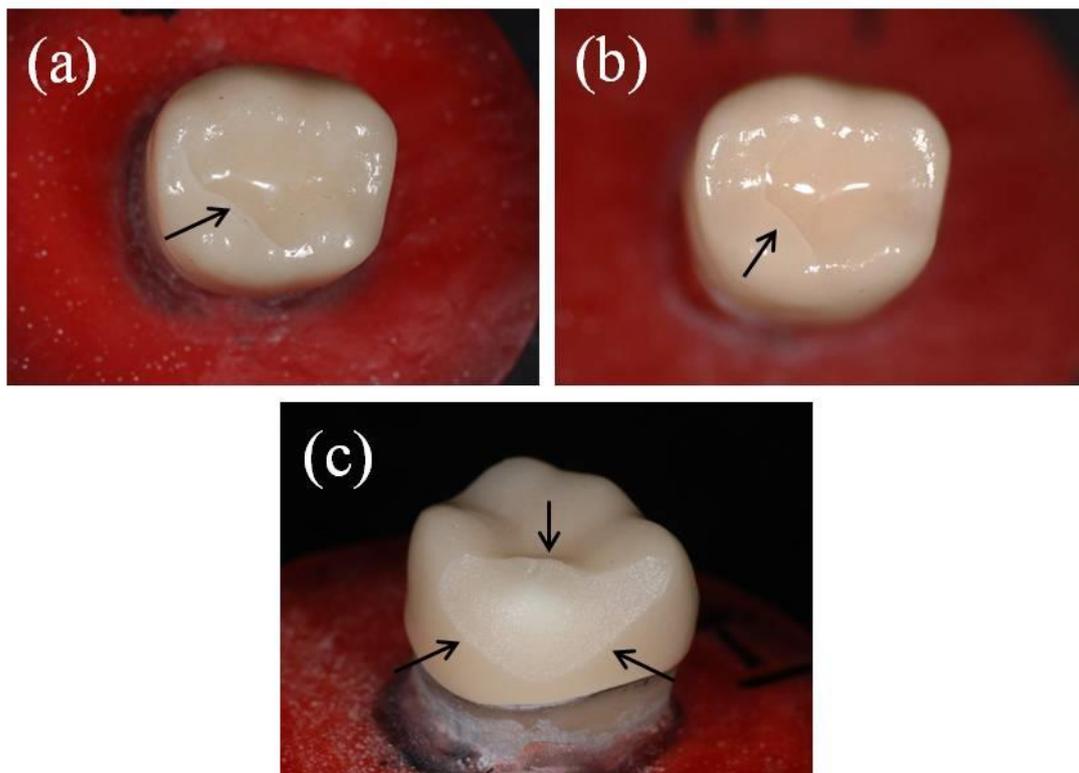
Figure 28. Photographs of prefailure after mechanical preloading in Group 1(+). Cracking of porcelain veneer (a, b); chipping of porcelain veneer (c). Black arrows indicate fracture lines.

After mechanical preloading, prefailure occurred only in Group 1(+), in which three crowns (25%) exhibited cracking or chipping of veneering porcelain (Figure 28). These crowns were excluded from subsequent fracture load.

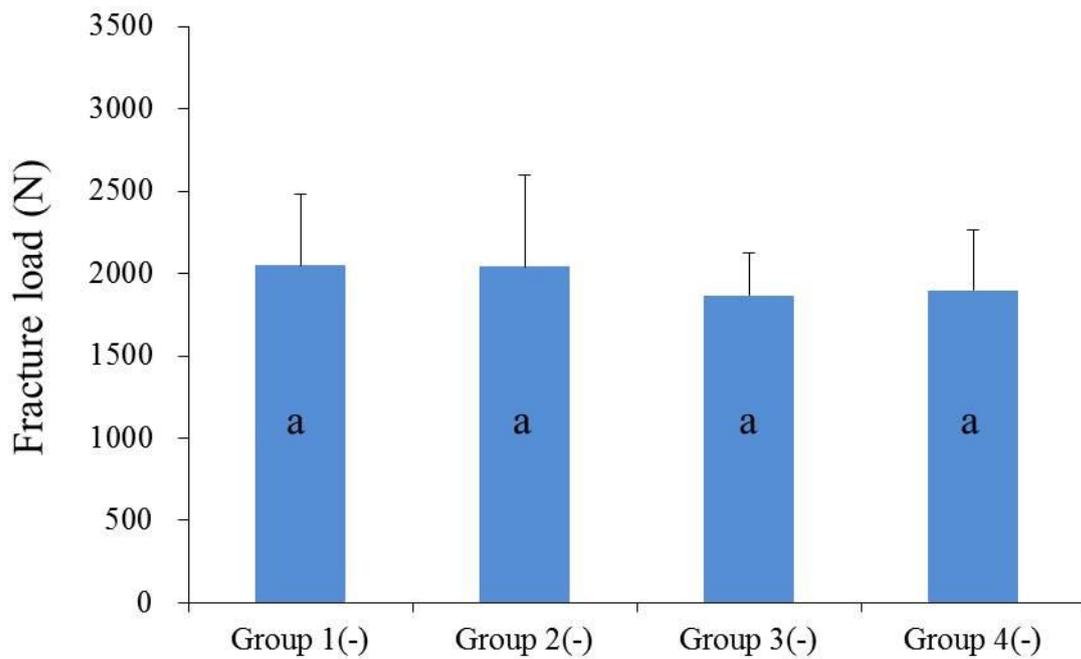
Fracture load ranged from 1866 ± 262 N (Group 3(-)) to 2049 ± 430 N (Group 1(-)) in the experimental groups without mechanical preloading (Figure 29). There was no significant difference in fracture loads between groups not subjected to mechanical preloading.

Figure 29. Fracture load in experimental groups without mechanical preloading. Groups labeled with the same letter are not statically different ($p > 0.05$).

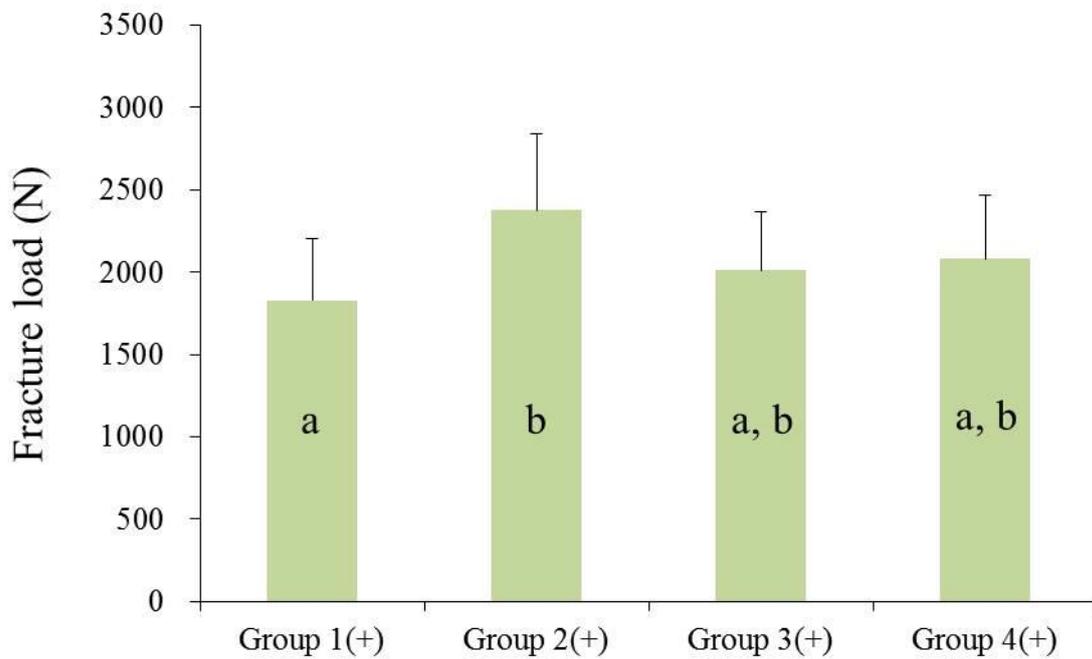
Conversely, fracture load ranged from 1828 ± 374 N (Group 1(+)) to 2374 ± 464 N (Group 2(+)) in the experimental group with mechanical preloading (Figure 30). Fracture load was significantly higher in Group 2(+) than in Group 1(+) ($p < 0.05$); however, no significant difference was found between Groups 2(+) and 3(+), and Groups 2(+) and 4(+).

Figure 30. Fracture load in experimental groups with mechanical preloading. Groups labeled with different letters are statically different ($p < 0.05$).

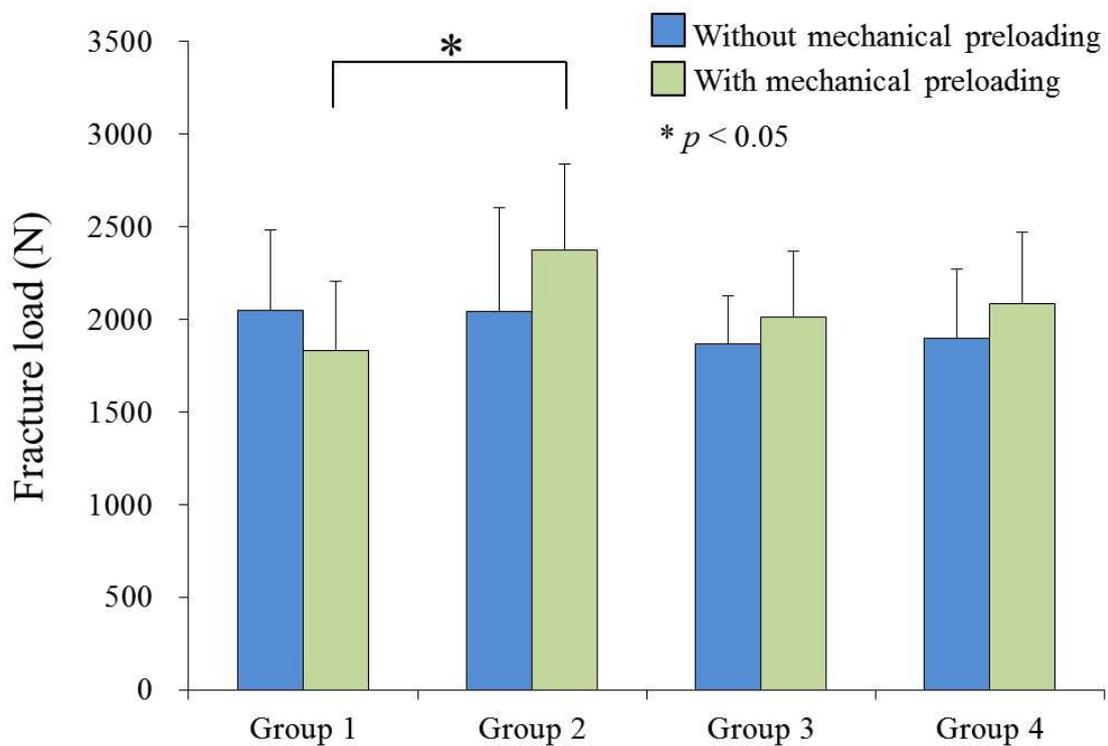
In the chewing simulation, fracture load tended to decrease after mechanical preloading in frameworks with no additional supporting structure (Group 1), but tended to increase in frameworks with additional supporting structures (Groups 2, 3, and 4) (Figure 31).

Figure 31. Comparison of the fracture load results after chewing simulation in each experimental group. The asterisk indicates statistical significance ($p < 0.05$).

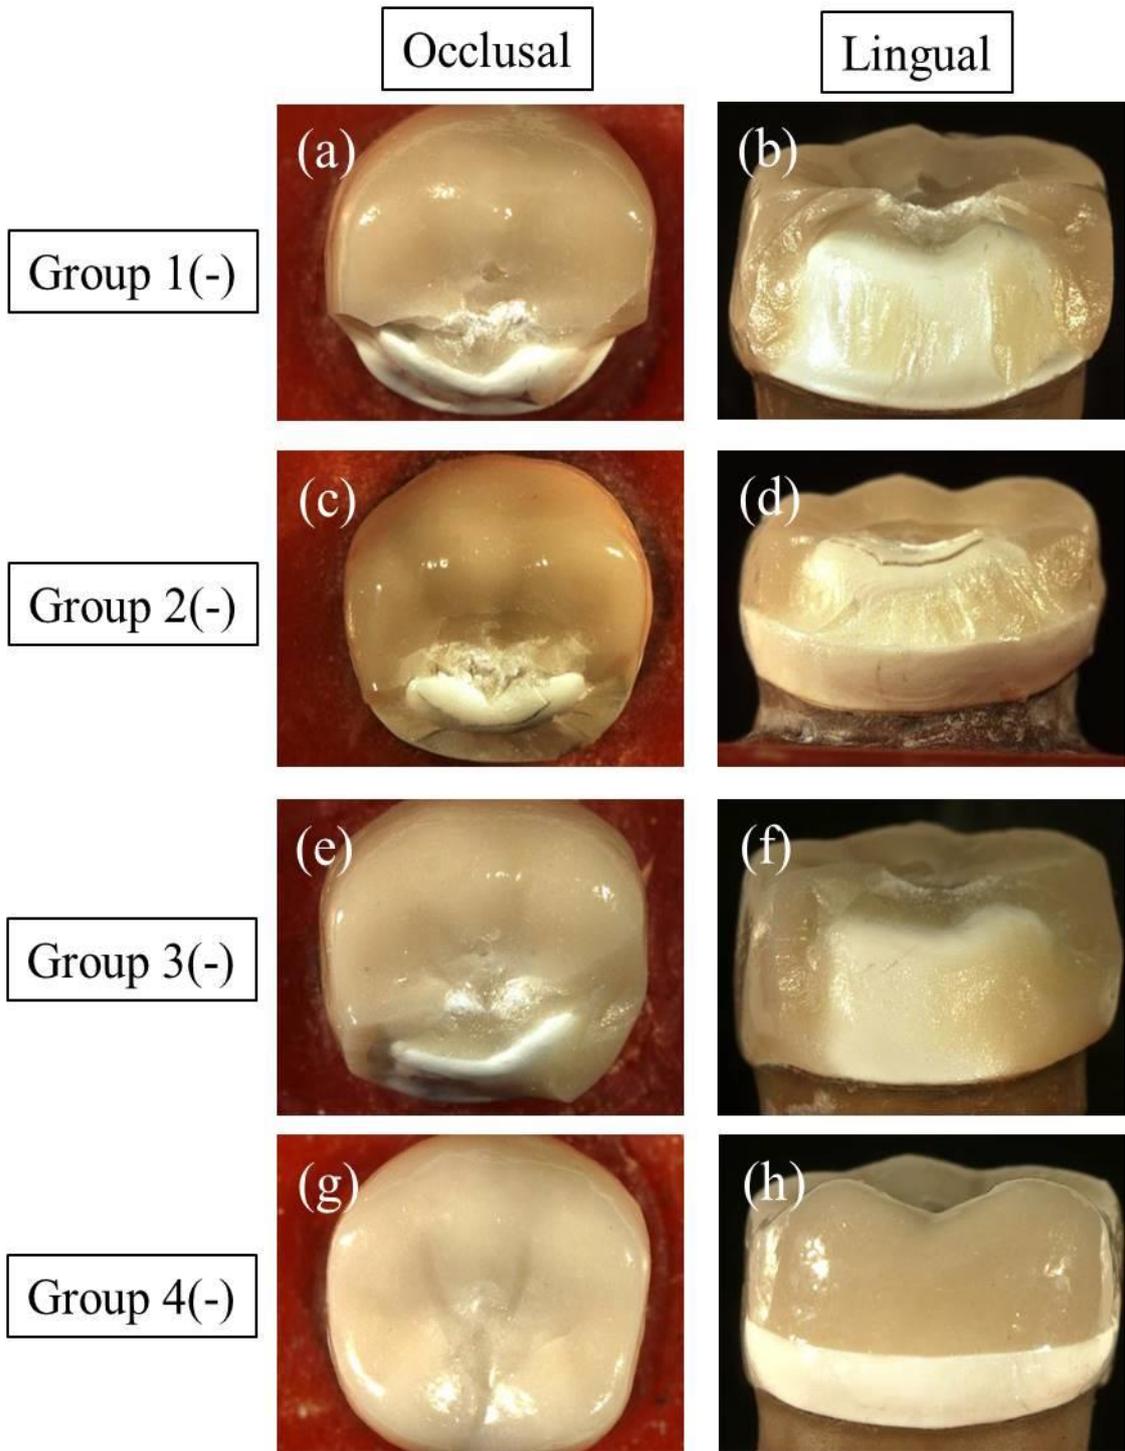
Figure 32. Stereomicroscopy of Ce-TZP/A crowns in Groups 1–4(-).

After fracture loading test, one partial fracture type, cracking of porcelain veneer, was observed in all experimental groups except for Group 3(-). Three cases of cracking each occurred in Groups 1(-) and 2(-), and two cases each occurred in Groups 4(-) and 1–4(+)
(Figure 32 g, h). The cracked area was limited to the occlusal surface (Figure 37).

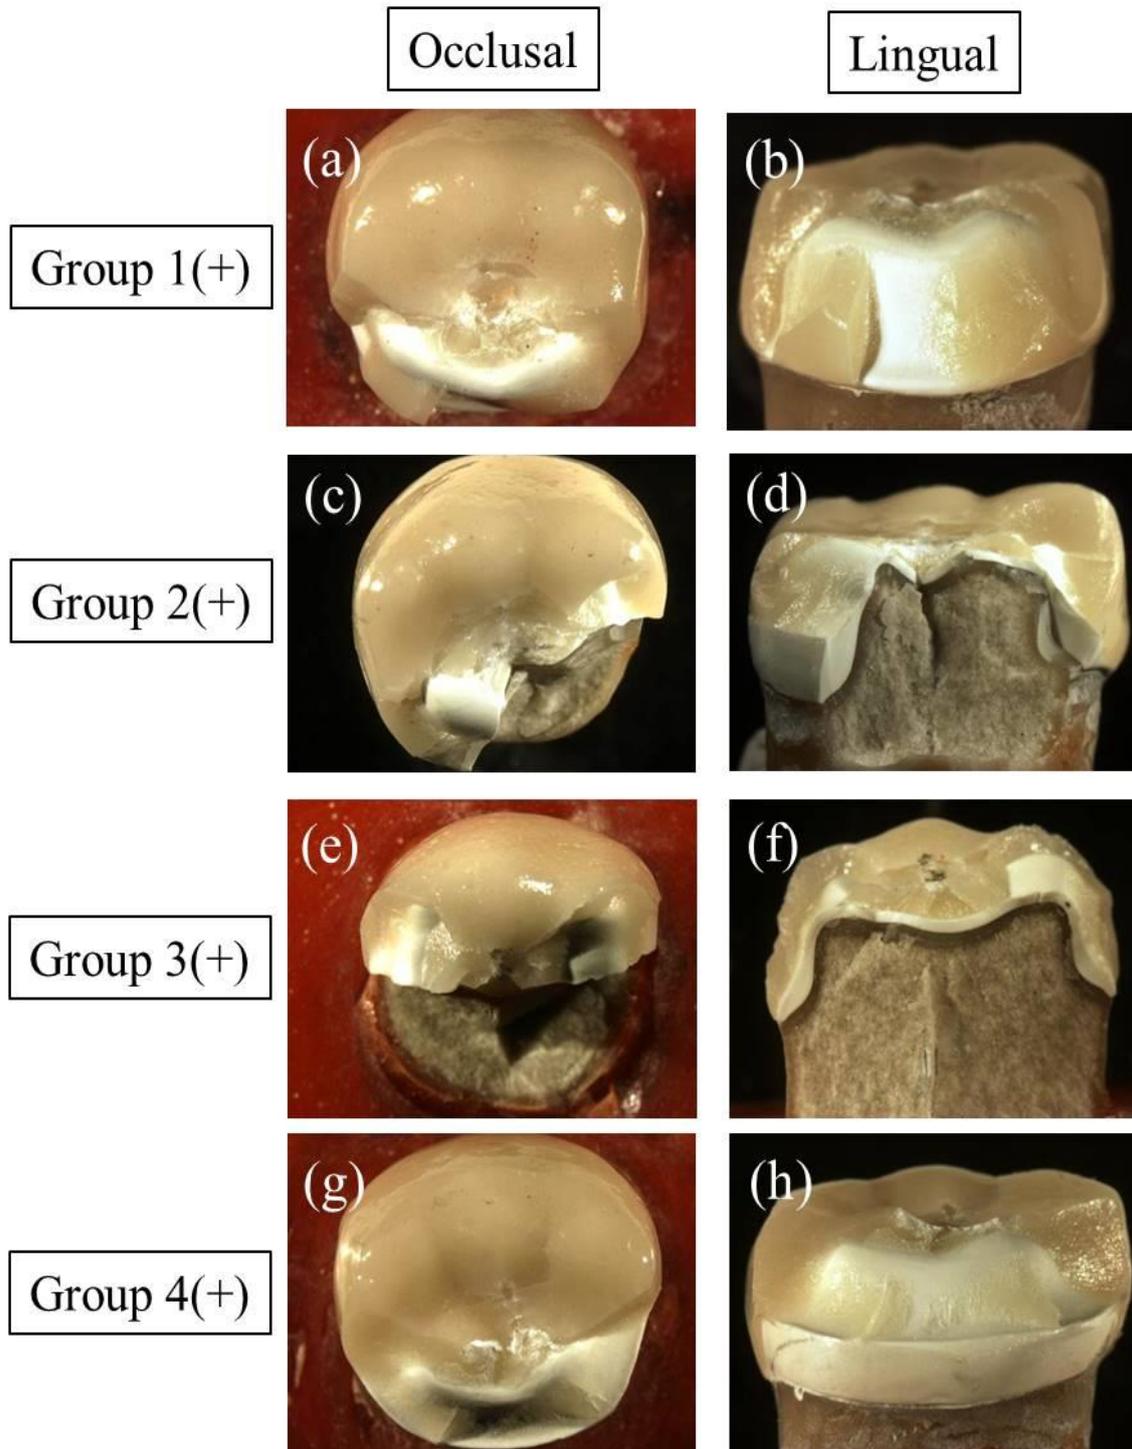
Figure 33. Stereomicroscopy of Ce-TZP/A crowns in Groups 1–4(+).

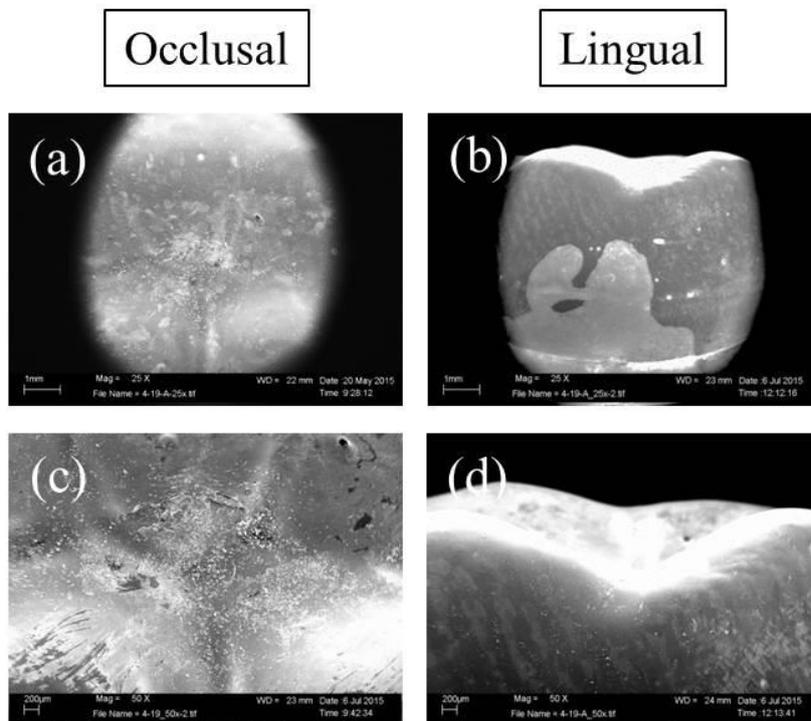
Figure 37. Scanning electron microscopy of Ce-TZP/A crown from Group 4(-). Magnification: a, b, 25 \times ; c, d, 50 \times .

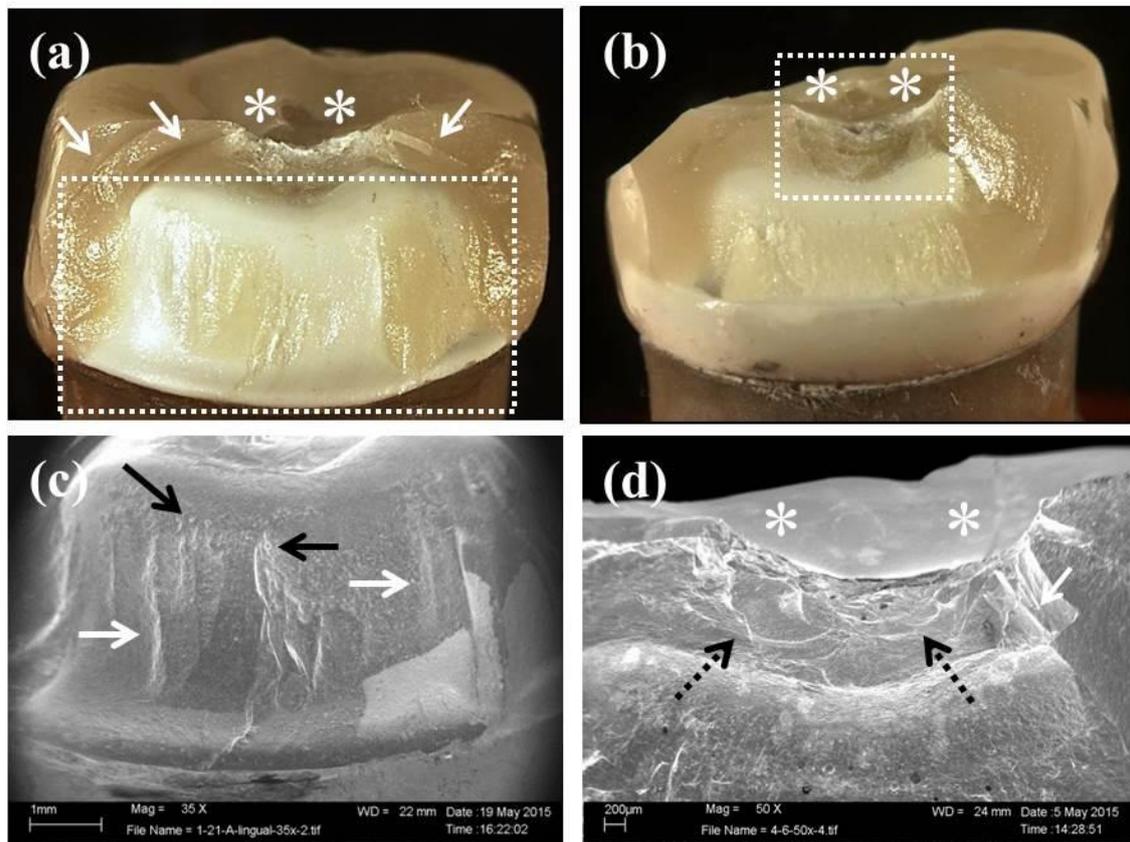
Stereomicroscopy and SEM revealed hackles (Figure 42, white arrows); wake hackles (Figure 42, black arrows); and arrest lines (Figure 42, black dotted arrows), indicating the direction of crack propagation towards the cervical margin and proximal area. The lingual side of Ce-TZP/A framework was exposed in more than half of specimens in each experimental group (Figure 42 a, b). In Group 4, the crack ratio on the buccal supporting structure was increased (Figure 44, black arrows).

Figure 42. Stereomicroscopy (overview; a, d) and scanning electron microscopy (detail; b, c) observations of chipping of porcelain veneer. Asterisks, white arrows, black arrows, and black dotted arrows show load-bearing points, hackles, wake hackles, and arrest lines, respectively.

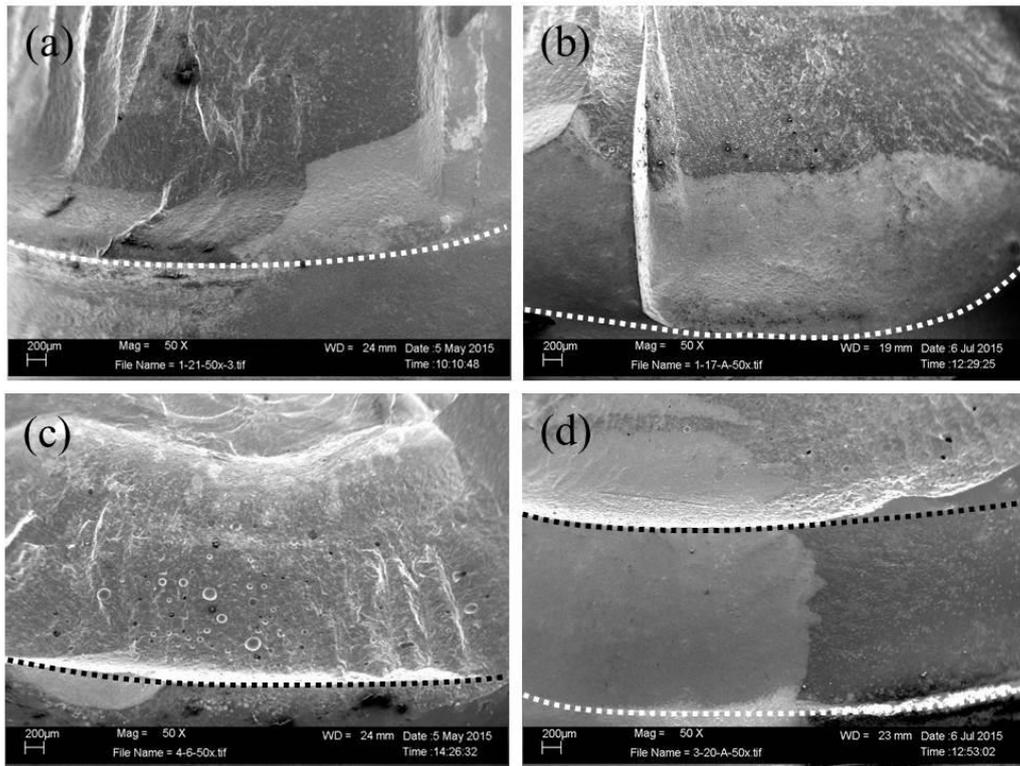
Figure 43. Scanning electron microscopy comparison of failure progression: (a, b) non-lingual supporting structure; (c, d) lingual supporting structure (50× magnification). White and black dotted lines indicate the lingual cervical margin and interface of the lingual supporting structure, respectively.
