**Effect of a novel framework design in ceria-stabilized
zirconia/alumina nanocomposite (Ce-TZP/A)-based
all-ceramic crowns**

**Inaugural-Dissertation
zur Erlangung des Doktorgrades
der Zahnheilkunde**

**der Medizinischen Fakultät
der Eberhard Karls Universität
zu Tübingen**

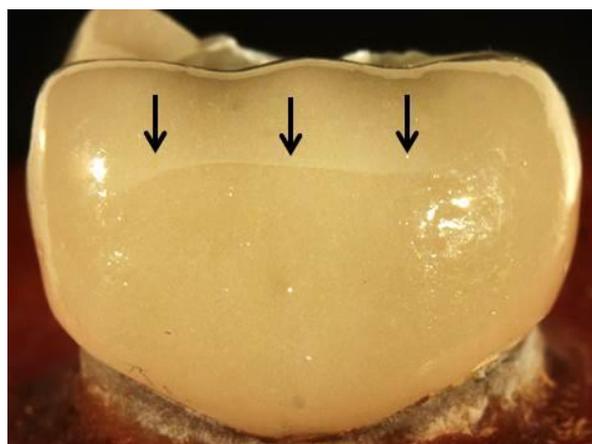
Figure 44. Stereomicroscopy observation of chipping of porcelain veneer (buccal side aspect) in Group 4. Black arrows indicate cracks.

Stereomicroscopy and SEM revealed hackles (Figure 42, white arrows); wake hackles (Figure 42, black arrows); and arrest lines (Figure 42, black dotted arrows), indicating the direction of crack propagation towards the cervical margin and proximal area. The lingual side of Ce-TZP/A framework was exposed in more than half of specimens in each experimental group (Figure 42 a, b). In Group 4, the crack ratio on the buccal supporting structure was increased (Figure 44, black arrows).

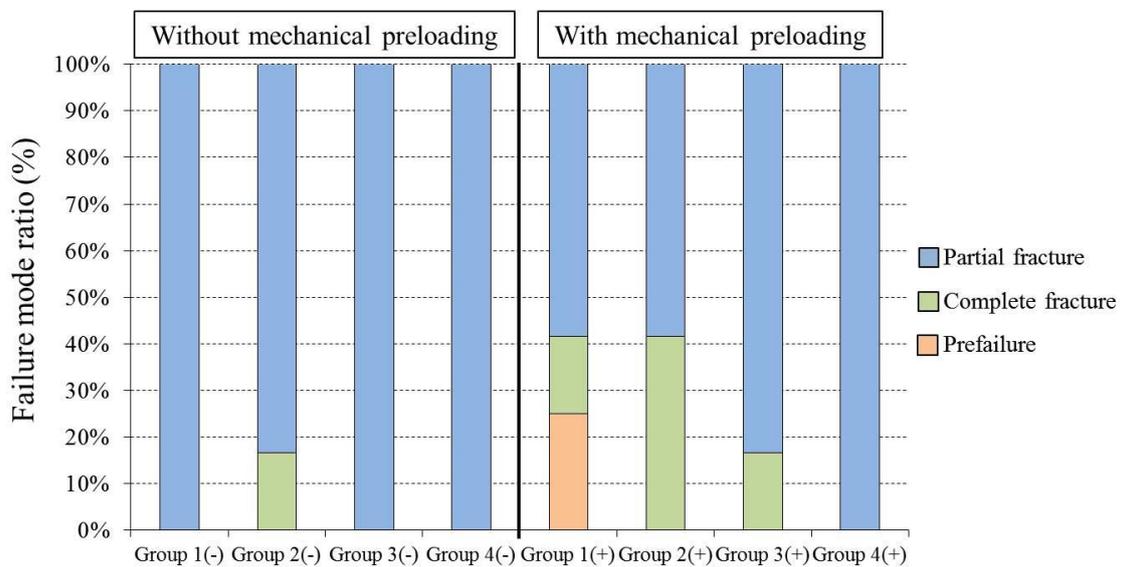
Figure 45. Failure mode ratios after mechanical preloading. Prefailure, partial fracture (cracking or chipping of porcelain veneer), and complete fracture (fracture of Ce-TZP/A framework or tooth analog).

The complete fracture ratios were 16.7–41.7% in Groups 1–3 after mechanical preloading. Failure mode shifted from partial to complete fracture, and complete fracture of Group 1(+) was significantly higher than that of Group 1(-) ($p = 0.0372$). However, for Group 4(+), the partial fracture ratio still remained at 100% and complete fracture was significantly lower ($p = 0.0395$).

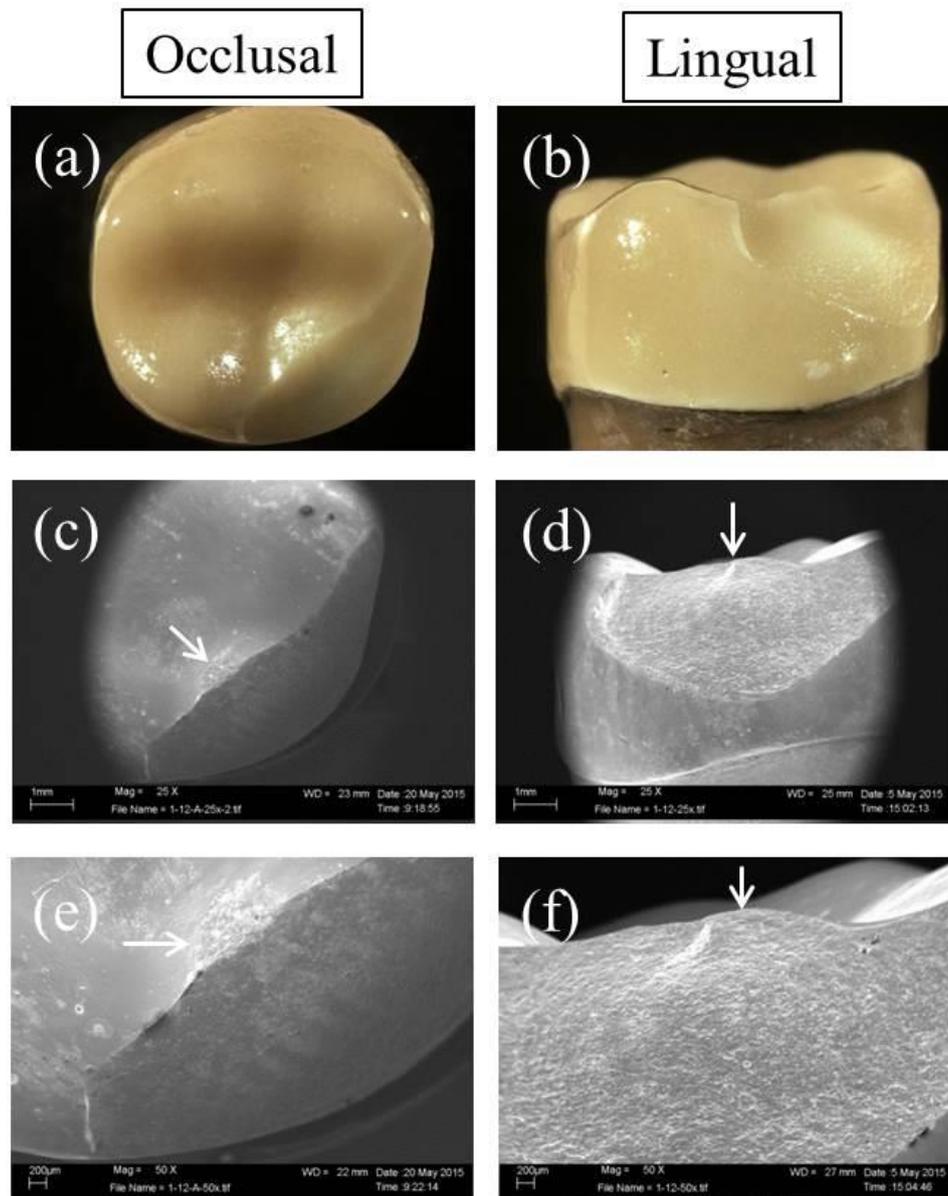
Figure 46. Stereomicroscopy (a, b) and scanning electron microscopy (c–f) of Ce-TZP/A crown from Group 1(+) with prefailure after mechanical preloading. White arrows indicate the starting point of the fracture (c–f). Magnification: a, 7 \times ; b, 8 \times ; c, d, 25 \times ; e, f, 50 \times .)

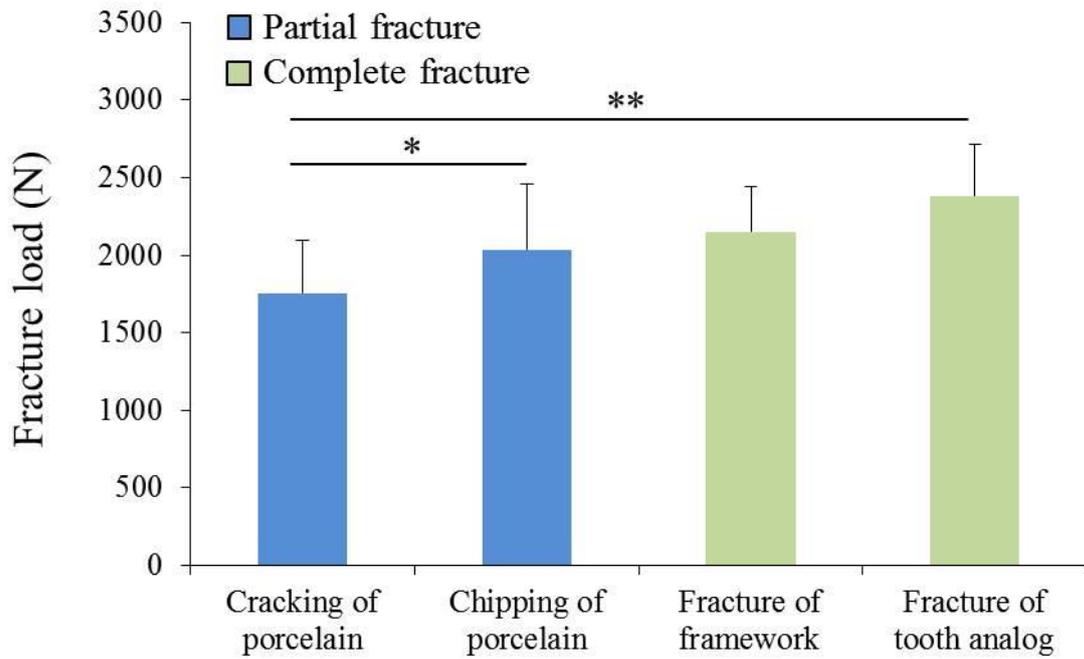
Figure 47. Fracture load in each failure mode. Results were analyzed with a 1-way analysis of variance and a post hoc Tukey's test. Asterisks indicate significant difference (** $p < 0.01$, * $p < 0.05$).

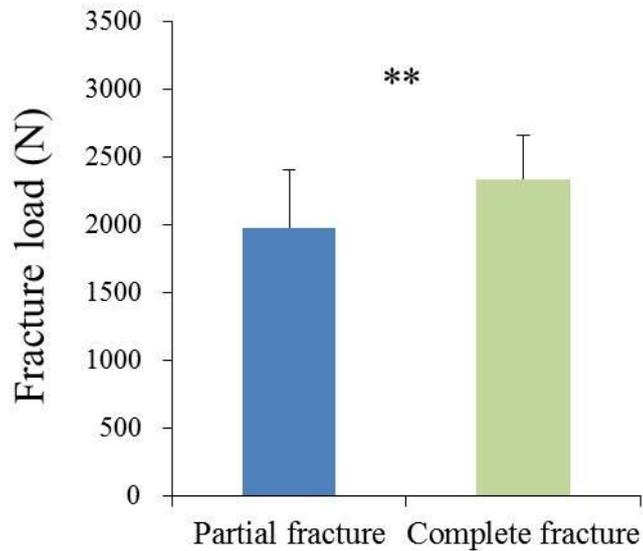
Figure 48. Comparison of fracture loads between different failure modes. Asterisks indicate significant difference (** $p < 0.01$).
